Tankerhoosen River Watershed Management Plan

Friends of the Hockanum River Linear Park of Vernon, Inc.

March 2009

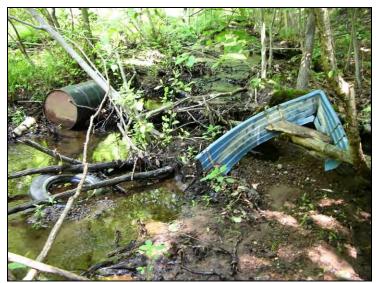
Trash and debris along reach CB-02

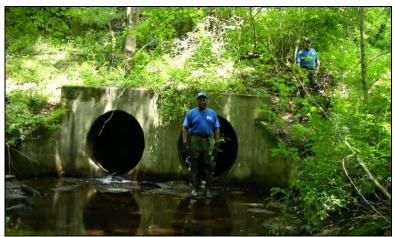
Bamforth Road crossing (perched culvert) along reach CB-03

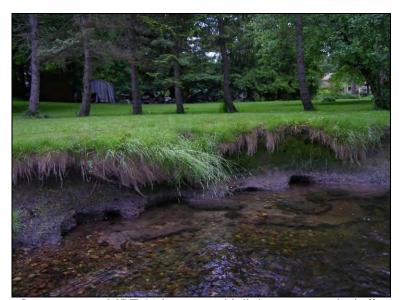
Stream segment MRT-01 has areas with little or no vegetative buffer.

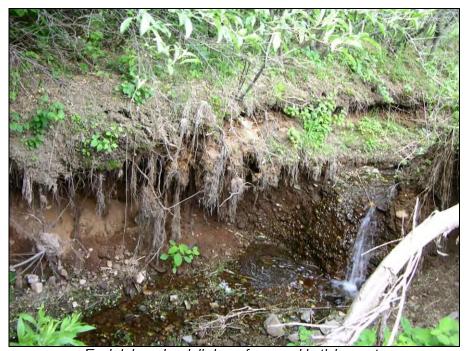
• OT —Stormwater outfall OT-01 is an earthen channel located on the left bank upstream of the Route 31 crossing. The channel originates from an adjacent residential property and was observed to have significant (3 to 4 feet deep) headcutting (erosion of the channel progressing upstream). A moderate flow of clear water was discharging from the channel at the time of the inspection. The property owner indicated that the source of the flow is groundwater seepage and surface runoff from upgradient areas. A discharge investigation is recommended, and this channel is a potential candidate for stream bank stabilization. The second outfall, OT-02, is a paved asphalt channel on the right bank, 8-inches deep and approximately 3 feet wide. The channel conveys road runoff.

Eroded channel and discharge from a residential property.

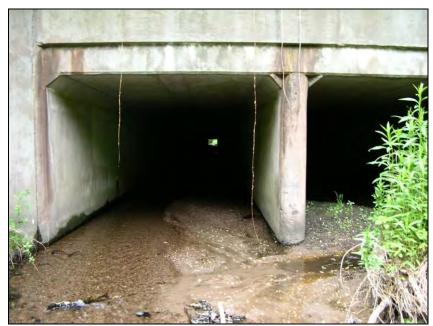
Twin box culvert along reach WR-05 underneath the onramp for I-84.

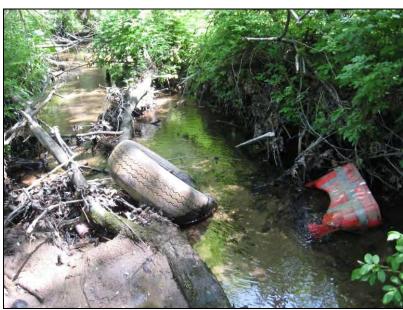
- RCH The stream is mostly shaded with some evidence of sediment deposition. Instream habitat was marginal, with other in-stream metrics ranging from suboptimal to optimal. The reach includes a high-quality buffer and good floodplain connection, with associated metrics ranging from suboptimal to optimal.
- TR A small quantity of automotive debris was observed and should be removed. Access is difficult, although cleanup would be straightforward.

Trash and debris in stream segment GB-02

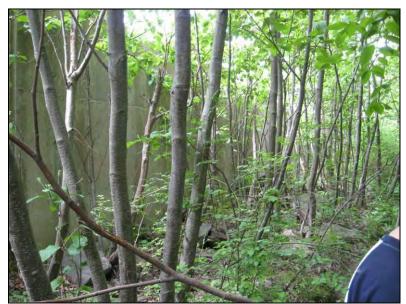
Concrete retaining wall adjacent to Gerber Drive along segment GB-03B

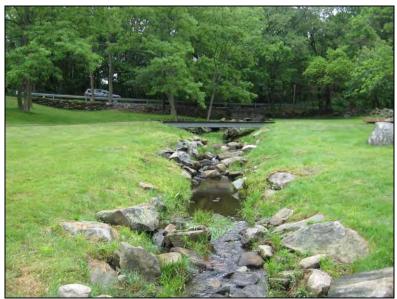
Stream segment GB-05B showing limited vegetative buffer and a small footbridge crossing the stream.

• IB —Little or no vegetative buffer exists along the stream through the commercial/office building site. Mowed lawn borders much of the stream on both sides, and several footbridges have been constructed over the stream. This stream segment is a potential candidate for stream buffer restoration.

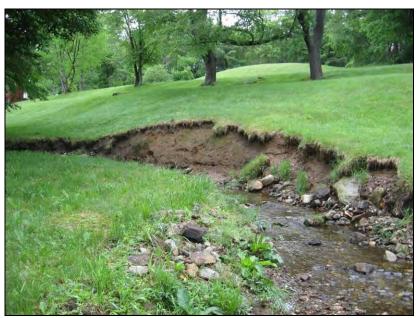
Stream segment GB-05B showing area of stream bank erosion.

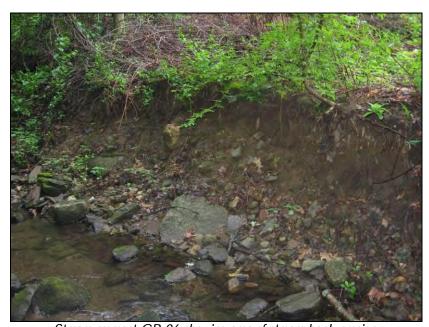
- ER Numerous areas of significant erosion were identified along this stream segment. Three areas of bank scour on the outside banks of bends were observed. One area included a low-head concrete dam where the stream eroded the abutment, creating a bypass channel around the structure. The last area included active downcutting ending at a nick point behind several residences at the terminus of the reach. These areas are potential candidates for stream bank stabilization.

Stream segment GB-06 showing area of stream bank erosion.

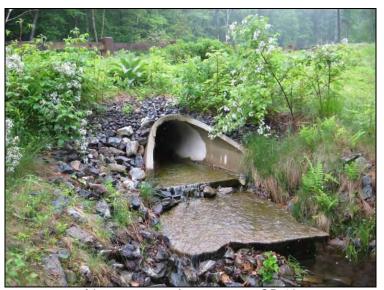
- SC A new stream crossing was observed under the subdivision road, consisting of a 24-inch concrete pipe. A boulder was present below the flared-end outlet. The culvert outlet is perched several inches above the stream bed, and the depth of flow in the pipe was approximately 1-inch. Due to the headwater location of the culvert, upstream fish passage is unlikely to be an issue in this portion of the watershed.

New stream crossing on segment GB-10.

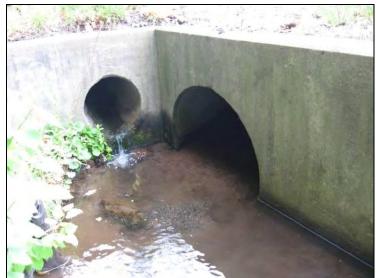
- SC This stream crossing conveys the tributary below Interstate 84. The crossing is a concrete culvert several hundred feet long. The crossing is partially blocked by accumulated sediment.

Stream crossing (SC-01) below I-84 and outfall (OT-03) along reach GBST-02.

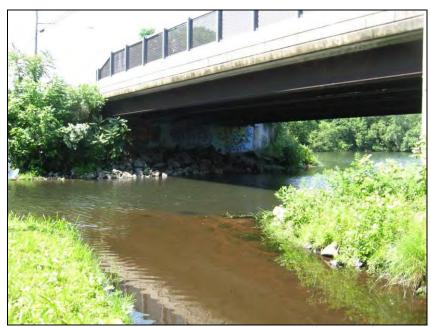
The left and right streambanks along the lower portion of Tucker Brook (foreground) at the confluence with the Tankerhoosen River (background) are potential candidates for reforestation.

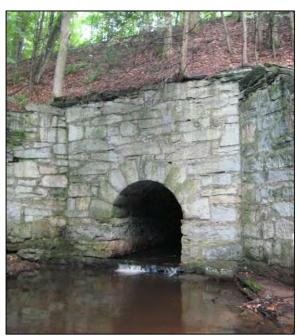
Arch-type railroad crossing (SC-02) constructed of stone and extending approximately 125 feet. The crossing may prevent fish passage and is suffering from downstream scour evidenced by the large pool shown in the photograph.

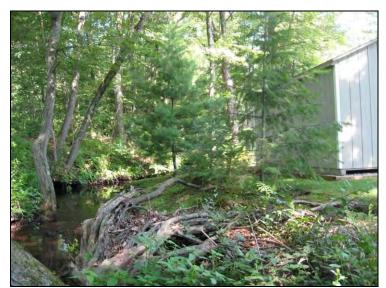
This section of river is abutted by residential properties along the right bank and has an impacted buffer on this side of the stream from lawn vegetation and items such as this shed.

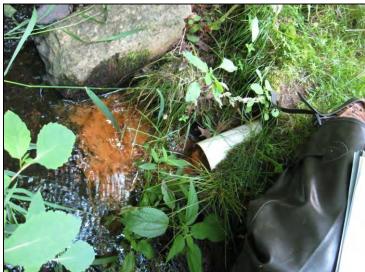
- RCH —The stream segment flows behind houses, often adjacent to the property line.
 The close proximity of the stream to these residences has resulted in numerous
 stormwater outfalls, impacted buffers, stream crossings, and occurrences of trash and
 debris in the stream.
- OT —There are five stormwater outfalls along this reach, ranging in size from 4 to 8inch diameter pipes. The outfalls appear to be associated with residential yard drains,
 foundation drains, or roof downspouts. All but one outfall pipe had dry weather flow at
 the time of inspection. The flowing outfall, OT-04, had a trickle of orange discharge,
 which may be naturally-occurring iron precipitate associated with groundwater
 discharge. A discharge investigation is recommended nevertheless to confirm the
 source of the discharge.

Outfall pipe originating from a residential property on the left bank of segment TB-04C.
