HISTORIC RESOURCES INVENTORY  
BUILDING AND STRUCTURES  
HIST-6 NEW 5/77

1. BUILDING NAME (Common)	(Historic)	
Private residence	Valley Falls Farm	
2. TOWN/CITY	VILLAGE	COUNTY
Vernon		Tolland
3. STREET AND NUMBER (and/or location)		
345 Valley Falls Road		
4. OWNER(S)		
Peter & Morris Darico (559 Bolton Rd. Vernon, CT 06066)	<input type="checkbox"/> Public <input checked="" type="checkbox"/> Private	
5. USE (Present)	(Historic)	
Two-family dwelling	Farmhouse	
6. ACCESSIBILITY TO PUBLIC:	EXTERIOR VISIBLE FROM PUBLIC ROAD	INTERIOR ACCESSIBLE
<input checked="" type="checkbox"/> Yes <input type="checkbox"/> No	<input type="checkbox"/> Yes <input checked="" type="checkbox"/> No	IF YES, EXPLAIN
7. STYLE OF BUILDING	DATE OF CONSTRUCTION	
Greek Revival	c.1850

Vernon Local Historic Properties Commission

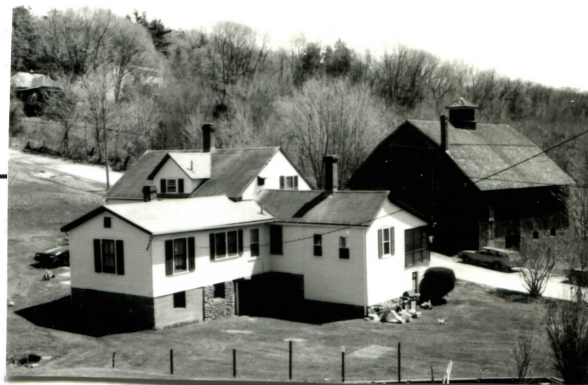
Looking south & west Roll 1, Neg. 6 & 8

11. NUMBER OF STORIES	APPROXIMATE DIMENSIONS	
1 1/2	56 ft. x 23 ft.	
12. CONDITION (Structural)	(Exterior)	
<input type="checkbox"/> Excellent <input checked="" type="checkbox"/> Good <input type="checkbox"/> Fair <input type="checkbox"/> Deteriorated	<input checked="" type="checkbox"/> Excellent <input type="checkbox"/> Good <input type="checkbox"/> Fair <input type="checkbox"/> Deteriorated

The main block of the house faces south with its ridge parallel to the facade. It rests on a granite foundation. Ells extend west and north. The west ell features a porch with turned posts, square balusters and sawn brackets. Windows have two-over-two sash; the entry door features wide pilasters and a panelled wood door. The most significant outbuilding is a large stable at the rear which has smooth, vertical siding, eight-over-eight windows, and a belvedere. Other outbuildings have been converted to garages and storage sheds.

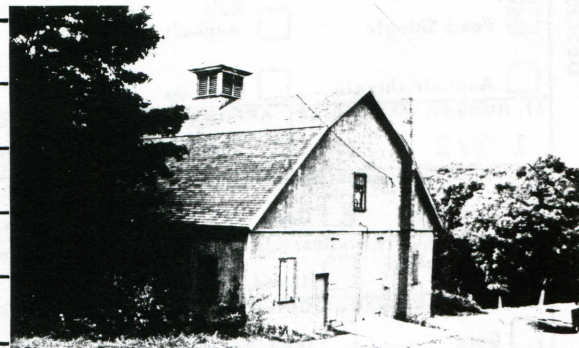
North Elevation

11. NUMBER OF STORIES		APPROXIMATE DIMENSIONS	
1 1/2		50 ft. x 60 ft.	
12. CONDITION (Structural)			
<input type="checkbox"/> Excellent	<input checked="" type="checkbox"/> Good	<input type="checkbox"/> Fair	<input type="checkbox"/> Deteriorated
(Exterior)			
<input type="checkbox"/> Excellent	<input type="checkbox"/> Good	<input checked="" type="checkbox"/> Fair	<input type="checkbox"/> Deteriorated

13. INTEGRITY (Location)		WHEN ?	(Alterations)
<input checked="" type="checkbox"/> On original site	<input type="checkbox"/> Moved		<input checked="" type="checkbox"/> Yes <input type="checkbox"/> No
		IF YES, EXPLAIN	
		Silo removed, date unknown

The barn features a rectangular plan and a wood-shingled gambrel roof with ventilating cupola at the mid-point of the ridge. It has overhanging eaves and rakes, smooth, vertical pine siding and a stone foundation. Its post and beam frame appears to be recycled from an earlier structure. The plan is that of a traditional bank barn with access from the road to both levels with livestock housed on the lower level.

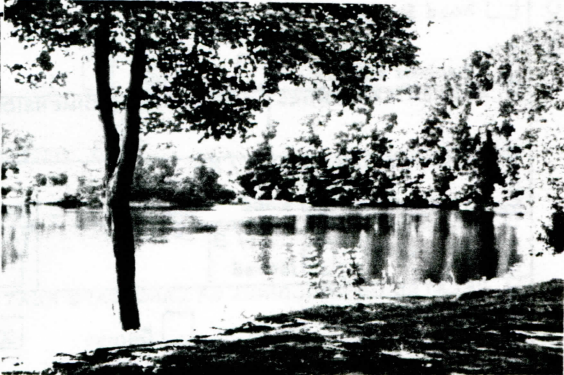
DESCRIPTION (Continued)	17. OTHER NOTABLE FEATURES OF BUILDING OR SITE (Interior and/or exterior)		
	<p>The park consists of 193 acres of open space watered by Railroad Brook, a small stream which flows through the park, dropping from an elevation of 571 feet at Notch Pond in Bolton to an elevation of 343 feet at Valley Falls Pond. The brook is bordered by steep slopes on the west and rolling hills on the east. The pond is used by the town as a public swimming pool. Beach sand has been introduced on the north bank. The park is also used for hiking on marked trails. Natural vegetation and second-growth forest has been preserved.</p>		
SIGNIFICANCE	18. ARCHITECT		BUILDER
	n/a		n/a
SIGNIFICANCE	19. HISTORICAL OR ARCHITECTURAL IMPORTANCE		
	<p>The park was once a part of the mid-nineteenth century Valley Falls farm of Anson Lyman. In the mid-nineteenth century the brook was dammed and a pond created to provide water power for a mill. In the 1870s the brook was used as a fish hatchery. Later the farm became a summer retreat for the Beach family of Hartford. Today it is used for public recreation by the town of Vernon.</p>

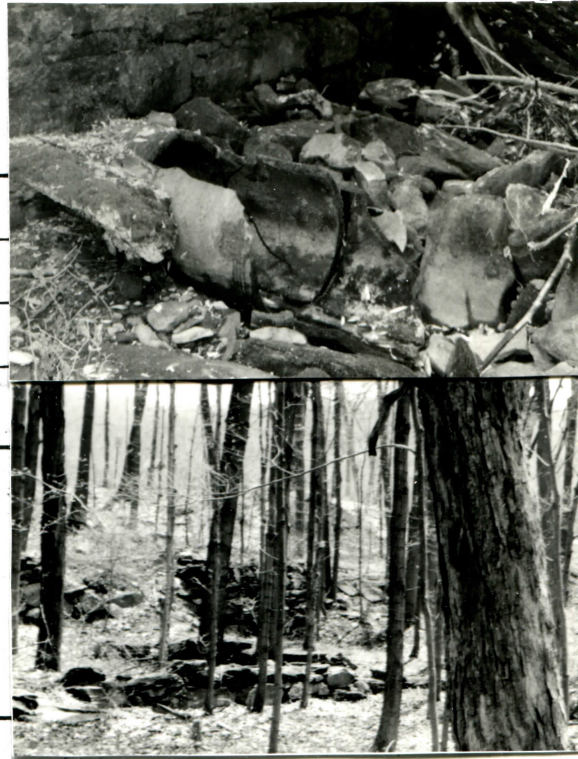
21. PUBLISHED REFERENCES			
	History of Tolland County, Tolland County Journal			
PHOTOGRAPH	22. RECOVERED DATA (Identify IN DETAIL, including structures, related outbuildings, landscape features, etc.).			
	<p>This site consists of above ground remains of three consecutive mill sites that occupied the area from 1741 until 1877.</p> <p>The features include remains of two stone foundations, one with stairs leading down to a cellar hole, a dam, pond, and stone wall.</p>			
ADD'L INFORMATION	23. ARCHAEOLOGICAL OR HISTORICAL IMPORTANCE			
	<p>This site represents 136 years of water powered industry.</p> <p>An archaeological investigation would help to determine the specific ways in which different manufacturers utilized a limited land base, while providing additional insight about the variety of Connecticut's mill industries</p> <p>See attached page for additional historical information</p>			
PHOTOGRAPH	PHOTOGRAPHER

This site represents the remains of three consecutive and dissimilar mills that occupied this area from 1741 until 1877.

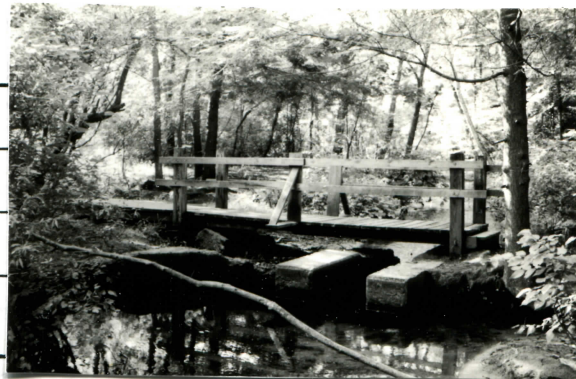
penstock

This site is an unusual example of a small commercial industry, and an early example of modern day wildlife resource management techniques. The joint use of the water-ways with the Valley Falls cotton mill helps illustrate the sharing of available resources in Eastern Connecticut.

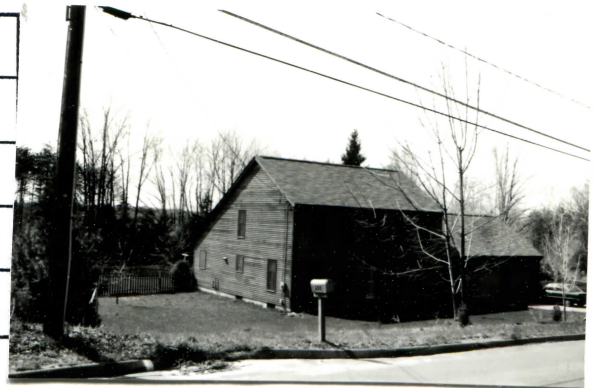
S. Ardis Abbott	4/23/94
	VIEW	NEGATIVE ON FILE
	East Elevation	Roll 1, Neg. 29
	NAME	DATE
	Valley Falls Farm Study Comm.	Jan. 1995
	ORGANIZATION	
	Vernon Local Historic Properties Commission	
	ADDRESS	
	14 Park Place, Rockville, CT 06066
