DEPARTMENT OF TRANSPORTATION

Project: State No.: 146-199
F.A.P. No.: 6146(017)
Project Title: Rehabilitation of Bridge #04575
Main Street over Tankerhoosen River
Town: Vernon

Subject: SHPO Consultation Documentation

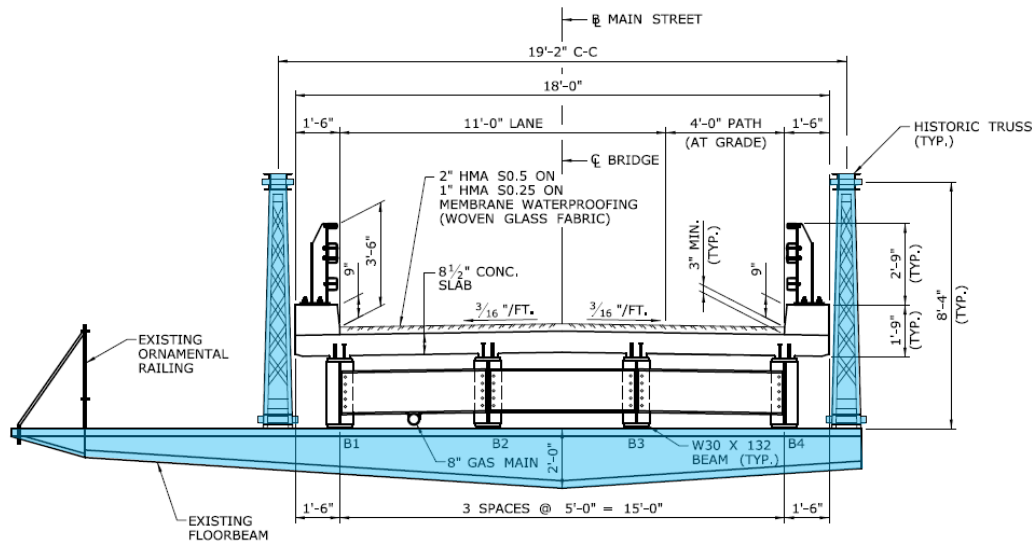
Figure 1: Detail of proposed cross section of rehabilitated Bridge #04575. The original truss members and girders (highlighted in blue) will be retained while a new superstructure will replace the 1985 system. Note that the new girders are installed just above the original beams. However, these two systems are independent and do not touch or bear on each other

Heeding this recommendation, the project has been resubmitted with an amended scope of work. The steel and concrete superstructure that has installed in 1985 will be replaced while the original lenticular truss elements and masonry substructure will be retained and repaired. Rather than the existing six-beam system, the replacement superstructure will consist of four rolled steel beams that will support an 8-1/2” thick reinforced concrete deck.

New cast-in-place concrete abutments will replace the concrete stem abutments that were installed in 1985. Like their predecessors, they will be installed behind the original masonry abutments and support the load of the new superstructure. The original masonry brownstone abutments will be rehabilitated by replacing missing stones and replacing missing mortar. The masonry abutments will then bear the load of the original lenticular trusses independently of the live load of the bridge.

The rehabilitated bridge will closely resemble its current appearance. It will remain a one-lane, alternating direction structure. The wearing surface will be restriped to allow for an 11-foot wide vehicle lane alongside a 4-foot wide pedestrian lane. The gas main currently carried on the original beams will be relocated between the new superstructure girders and will no longer be visible (figure 1).

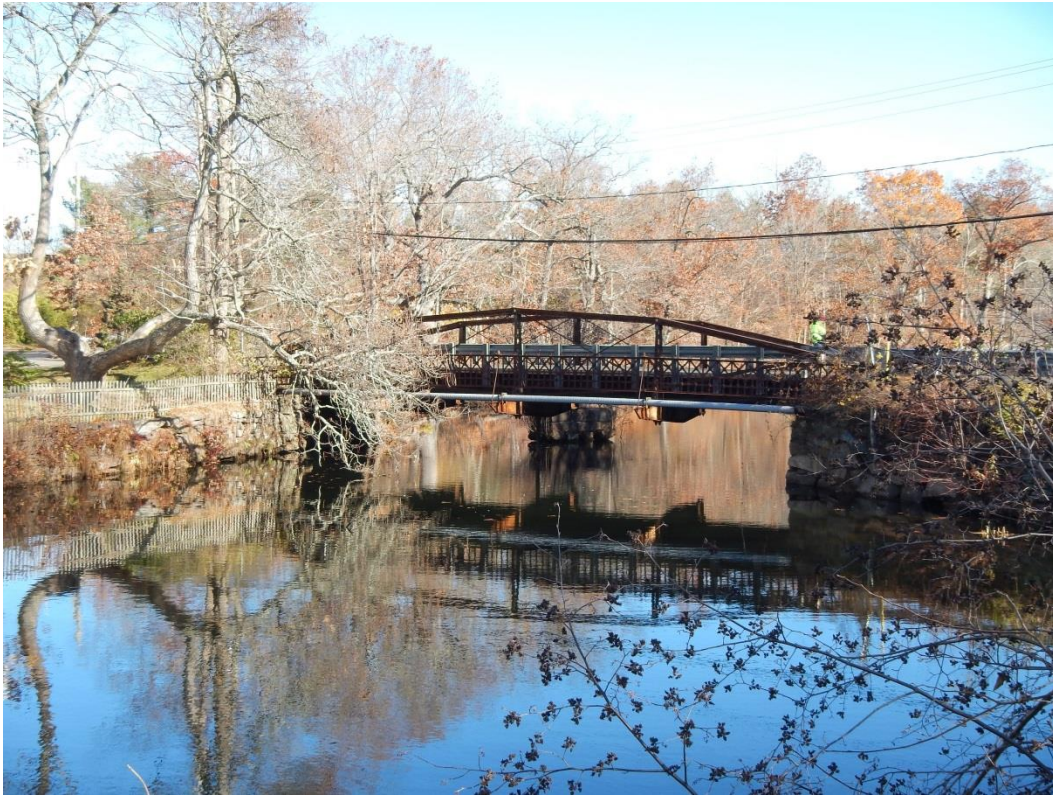
Image 1: Main Street Bridge #04575 over Tankerhoosen River.

The Town of Vernon proposes to rehabilitate the Bridge #04575, which carries Main Street over the Tankerhoosen River (Image 1). They will do so with technical assistance from the Connecticut Department of Transportation (CTDOT) and financial assistance from the Federal Highway Administration. Federal involvement brings the project under the purview of Section 106 of the National Historic Preservation Act. Additionally, Bridge #04575 is a rare extant example of a lenticular truss and a contributing element to the Talcottville Historic District.¹

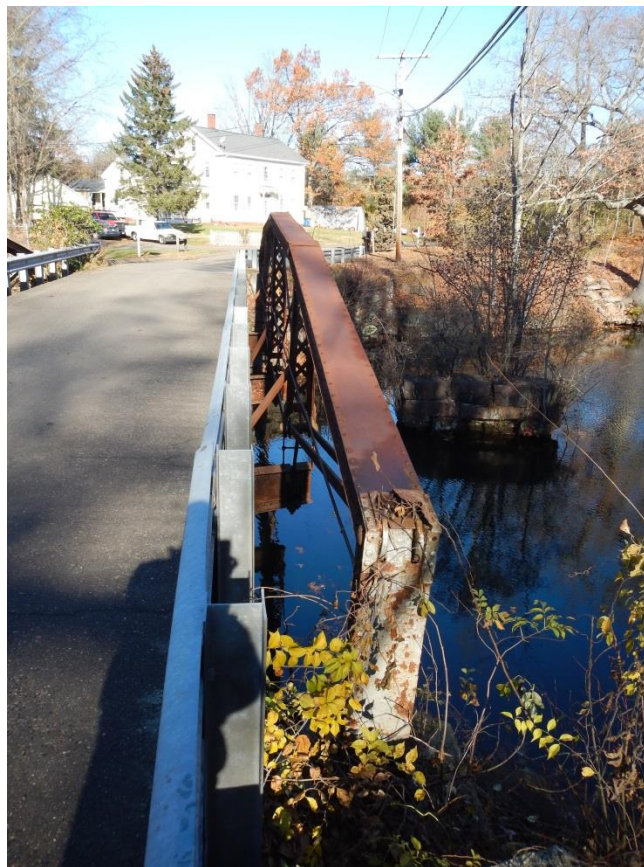
Image 2: The original truss supports its own weight on the brownstone abutments. The live load of the bridge is carried independently on a steel and concrete superstructure that was introduced in 1985. 11 Main Street is visible beyond the bridge.

The subject bridge was built in 1891 and underwent a significant rehabilitation in 1995. At that time, a new steel and concrete superstructure was introduced to carry the live load of traffic (Image 2). The original masonry abutments and wrought iron lenticular trusses were retained. State Project #146-199 proposes to replace the superstructure that was installed in 1985. The lenticular trusses will be rehabilitated and reinstalled to bear on their original masonry abutments. Construction is scheduled to commence in 2018 and is anticipated to be completed in one season.

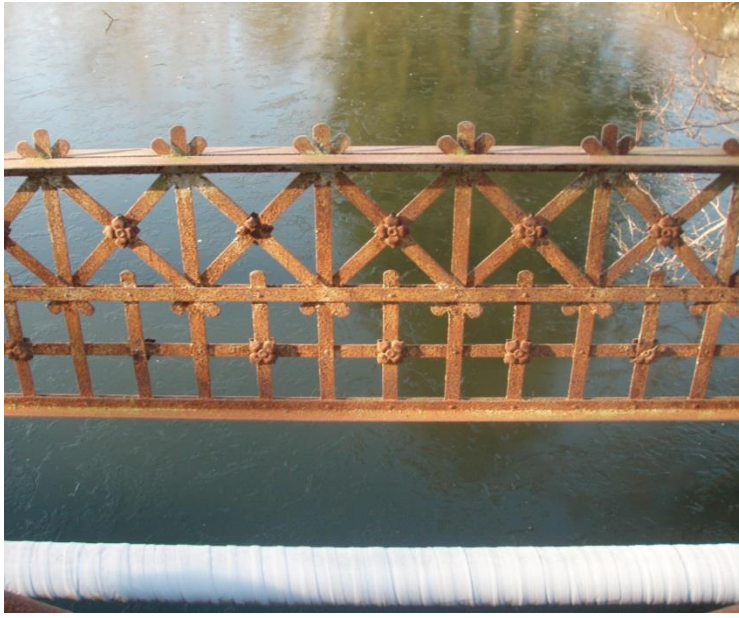
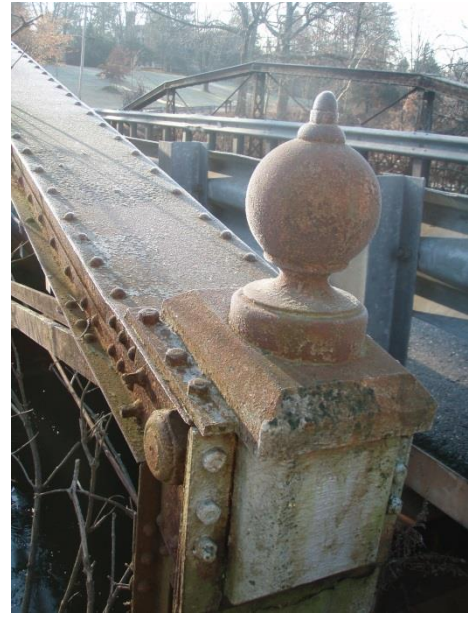
Image 3: Details of the lattice railing with cast iron rosettes and ball finial on Bridge #04575. These elements are original and distinctive of the Berlin Iron Bridge Company. Note that the grey gas line visible beneath the lattice railing will be relocated as part of this rehabilitation. It will no longer be visible within the replacement superstructure.

Bridge #04575 is a single span structure over a segment of the Tankerhoosen River just upstream of a spillway for the Talcottville mill. The bridge consists of a wrought-iron lenticular pony truss superstructure supported on brownstone masonry abutments. It retains several of its original decorative features, such as the distinctive lattice railing and one of its four original cast iron orb finials (Image 3). Its tapered floor beams extend beyond the roadway on the west side of the bridge and originally supported a wooden sidewalk. The sidewalk has been removed and the beams currently support a gas line.

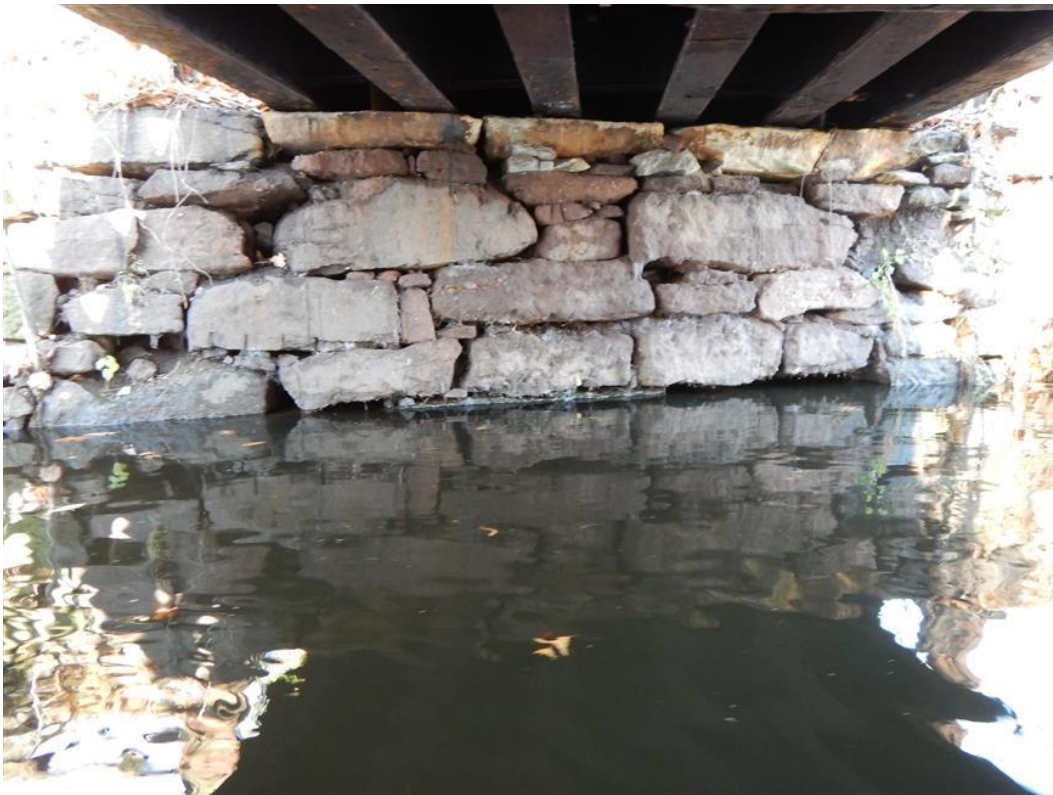
Image 4: North abutment of bridge. No mortar remains between the brownstone units and there are several voids in the abutment walls.

CTDOT’s Bridge Safety and Evaluation unit have assessed the subject bridge as being in Poor structural condition. This is largely due to the corrosion of the 1985 steel elements and deterioration of the bridge’s substructure. The abutments and wing walls exhibit large (up to 7’ x 5’) voids caused by missing stones (Image 4).
