Tankerhoosen River Watershed Management Plan

Friends of the Hockanum River Linear Park of Vernon, Inc.

March 2009

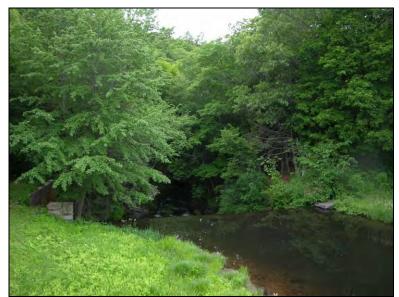
The upstream side of Dobsonville Pond dam at the upstream limit of reach LTR-03.

The photograph is taken near the confluence with reach TB-01.

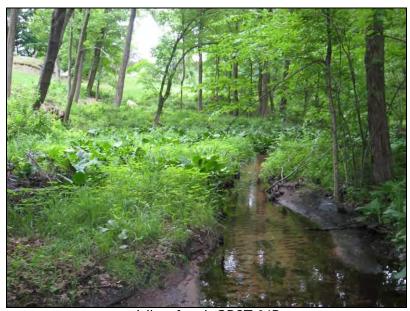
View of reach GBST-04B

• RCH - This reach is mostly shaded with a variable bottom of generally fine material (silt/clay, sand, and gravel). In-stream habitat was marginal, and dense invasive vegetation was present on both banks. Floodplain connection was optimal, however, since the stream was not deeply incised and high flows could easily enter the floodplain.

- IB Impacted buffer was present near the downstream end of this reach. In this area, the left bank is forested, although the right bank is vegetated with turf, lawn, and shrubs. A single-family home was also located near the stream.
- SC The upstream limit of this reach is located at Loehr Road. The stream flows below the road through a 60-inch corrugated metal pipe. The pipe was deformed at the downstream end, but the invert was inundated by tailwater, indicating that fish passage may be possible.

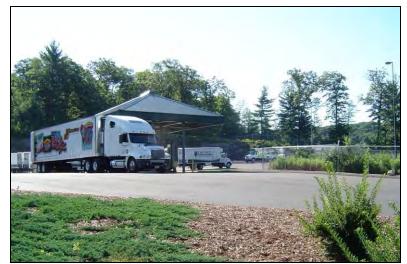
The Dari Farms distribution facility is also located in the Tolland Industrial Park on Research Way/Gerber Drive near the divide between the Gages Brook and Gages Brook South Tributary subwatersheds. The facility is estimated to be less than 5 years old, as evidenced by the facility's modern pollution prevention site design elements including a covered fueling station, no visible outdoor storage of materials, and well maintained landscaping on the grounds. Possible pollution sources to the storm drainage system are the runoff from the large impervious areas on the site (the roof and parking areas) and potential vehicle fluids from truck fueling activities and employee vehicles. It could not be determined whether stormwater is managed on-site, by the downgradient stormwater basin near the Gerber Technologies facility, or both. The site did not appear to incorporate Low Impact Development (LID) design features such as vegetated swales or parking lot bioretention. New commercial/industrial facilities with significant impervious area, such as this one, are potential candidates for on-site LID and stormwater treatment practices to reduce runoff volume and pollutant loads.

The Dari Farms Ice Cream Distribution Facility has a covered fueling station and landscaped grounds (shown in the foreground).

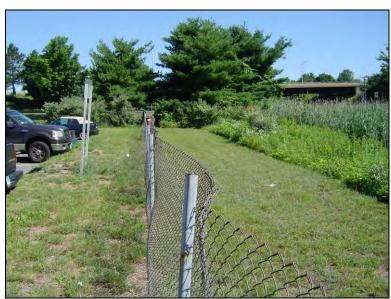
ConnDOT Commuter Parking Lot

The hotspot investigation included the Connecticut Department of Transportation commuter parking lot at exit 67 of Interstate-84, which is located in the Walker Reservoir subwatershed (see stream assessment discussion in Section 2.2.4). Approximately 150 vehicles were parked at the lot during the site visit, which occurred on a weekday during mid-day. The site is contains significant impervious cover and high-intensity vehicle usage and is therefore a source of automobile-related stormwater pollutants including hydrocarbons, sediment, and metals. The entire parking lot drains to a double catch basin located on the southeastern side of the lot. The catch basin discharges through a short wetland corridor and subsequently to the stream segment located upstream of Reservoir Road and Walker Reservoir East. An easily accessible grass strip exists between the paved lot and the adjacent wetland and stream corridor. This site is a potential stormwater retrofit candidate (bioretention or water quality swale) to encourage infiltration and provide additional treatment for the parking lot runoff.

The southeastern side of the Interstate 86 Exit 67 commuter parking lot showing the edge of the lot on the left side of the photograph and the wetland corridor on the right side. The center of the photograph shows the easily accessible and open area for a potential stormwater retrofit.

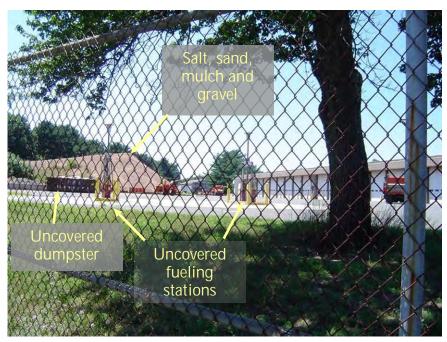
ConnDOT District #1 Maintenance Service Center, Campbell Avenue

The State of Connecticut operates a Department of Transportation Maintenance Service Center for District #1 located on Campbell Avenue in Vernon, which is located in the Lower Tankerhoosen River subwatershed. The facility has an office building, garages for vehicle storage and maintenance, a small parking lot, outdoor storage of sand, salt, gravel and mulch, and an uncovered outdoor fueling station. Vehicle maintenance activities and outdoor vehicle fueling are potential sources of stormwater pollution, in addition to the outdoor stockpile storage. A rolloff dumpster was observed to be overflowing and uncovered at the time of the windshield survey. Municipal and state-operated highway maintenance facilities such as this should employ source controls, pollution prevention, and stormwater treatment practices as necessary in accordance with the DEP General Permit for Stormwater Discharges Associated with Industrial Activity.

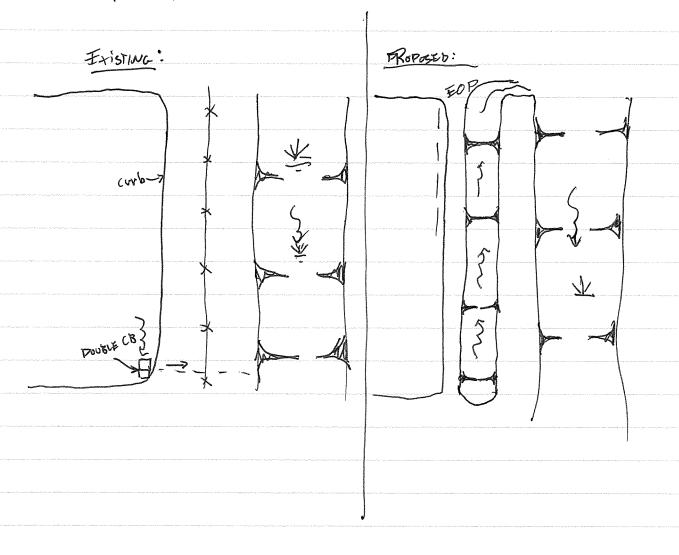
Discharge to wetland

Wide grass Strip between curb I wethound could be used for Swele
